WOLF CREEK DAM

NDS ID NO. PA-00664

PHASE I INSPECTION REPORT
NATIONAL DAM INSPECTION PROGRAM

AUGUST 1978

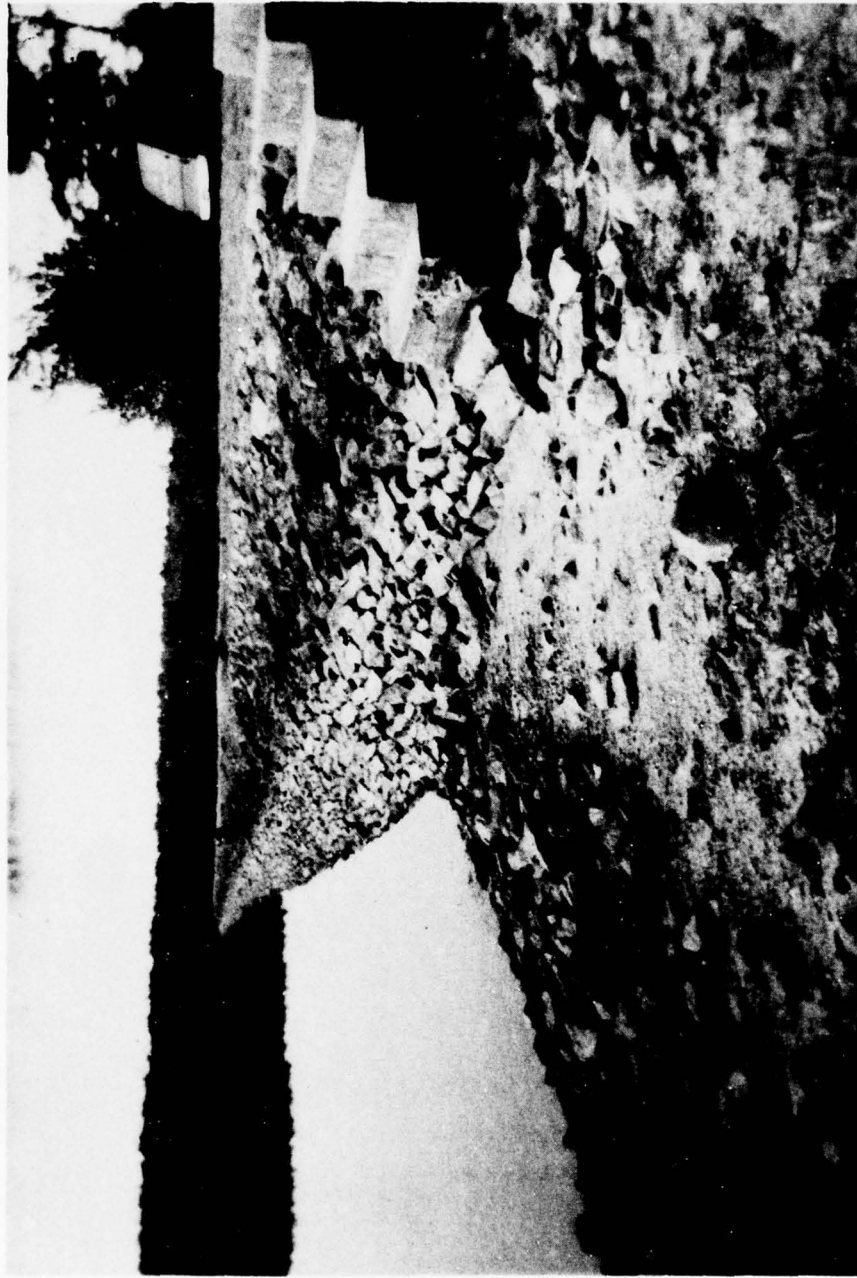
Upstream Slope of Embankment from Spillway Approach Channel

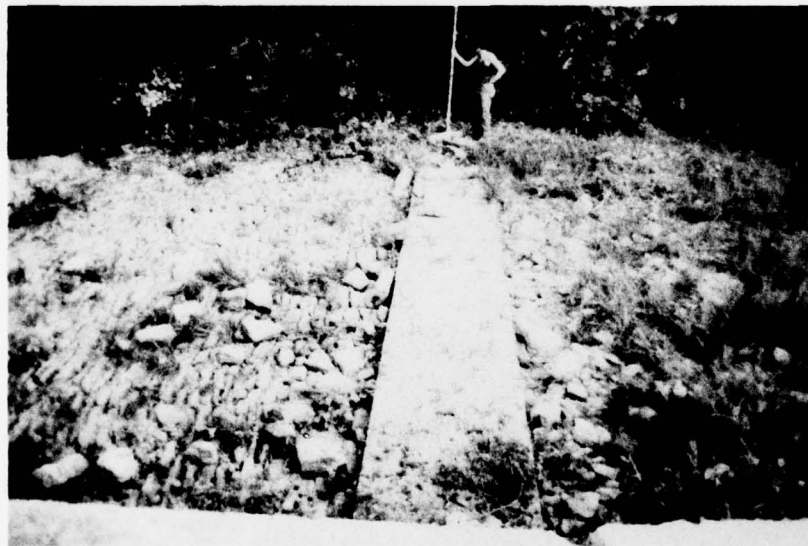
c. Appurtenant Structures. The right end of the spillway weir is indistinct where it joins the hillside (Photograph F). The right side of the approach channel has brush growing about 1 foot high (Photograph E). A survey performed for this inspection revealed that the invert elevation of the approach channel was from 0.1 to 0.7 foot higher than spillway crest elevation. Stumps up to 1.5 feet high and up to 3 inches in diameter were observed in the spillway discharge channel (Photograph H). There was some low brush growing at the left side of this channel. Where the discharge channel slope changes abruptly, to a 1V on 2H slope, severe weathering of the bedrock was observed (Photograph I). The spillway left wall has pattern cracking, especially near the upstream end. At the cracks, there was evidence of leaching, as white deposits or "efflorescence" was observed. This wall also has two larger cracks. The first crack is adjacent to the weir (Photograph G). Evidence of previous repairs was observed. The wall upstream of this crack is tilted toward the spillway. The upstream end is also slightly shifted toward the approach channel. The second crack is just downstream of the point where the wall deflects to the left. It is very fine with no apparent relative movement. The wall downstream of the crack is slightly tilted toward the spillway. Peeling was observed at the top and along the exposed toe of the wall.

burden. The reduction in spillway crest length from 60 feet in 1918 to 35 feet on the day of inspection could be an indication that the slope on the right of the spillway may be slowly sliding toward the spillway, although no visual evidence of sliding was observed during this inspection. The conditions in the approach channel affect the hydraulics and are evaluated in Section 5. Although the growth in the discharge channel was relatively low, the size of the stumps that were observed indicate that a more frequent brush cutting schedule is warranted. The weathering of the rock in the spillway discharge channel presents no hazard at present. Further weathering may start to undermine the wall at the left of the channel.

F. Concrete Spillway Weir and Masonry Apron —
Flow from Right to Left.

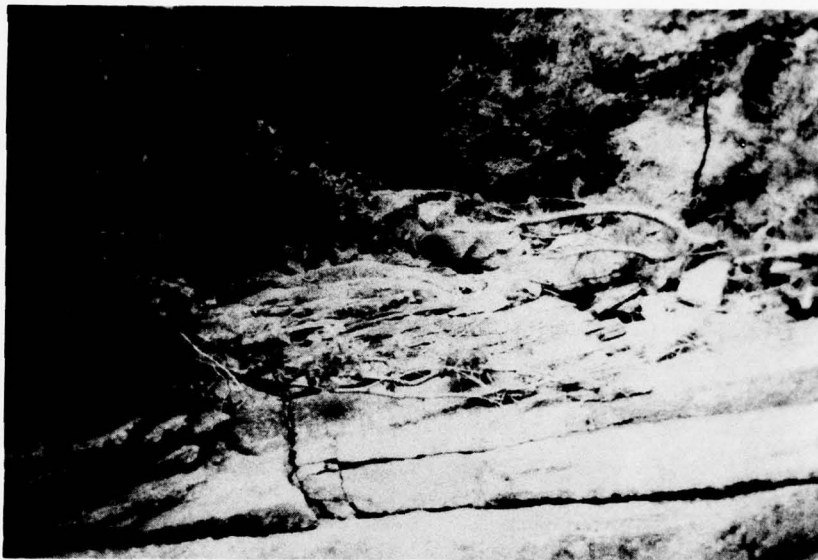
The spillway channel below the 1V on 2H drop is very poorly defined. Numerous shallow channels, blocked by substantial piles of debris, were observed.

I. Spillway Outlet Channel —
Looking Downstream at 1V on 2H Section.

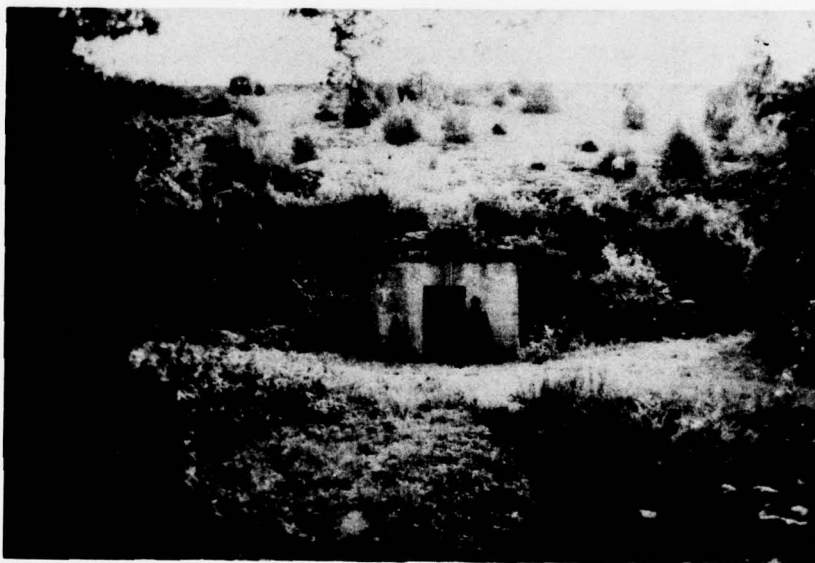
The outfall for the outlet works pipes is about 70 feet downstream of the valve house (Photograph J). The tops of both pipes are exposed for about 20 feet from the outfall (Photograph K). The bell end of these pipes is on the downstream end of each section of pipe. The 16-inch diameter pipe was discharging on the day of the inspection. The pipe joints were observed to leak severely.

J. Valve House at Toe of Downstream Slope of Embankment.

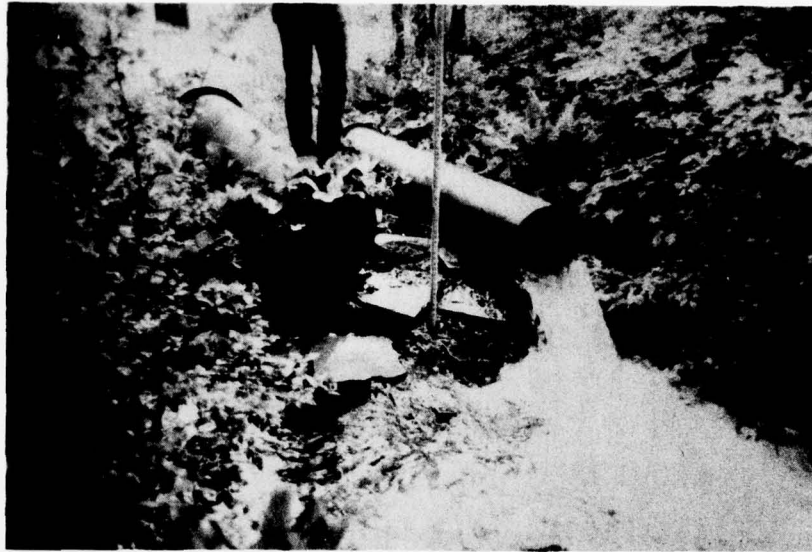
It is normal construction practice to lay pipe with the bell end upstream. The leakage observed at the joints indicates that poor joint construction practices were utilized. If the joints leak upstream of the exposed length of pipe, this could be contributing to the observed seepage. As one of these pipes extends under pressure through the embankment, there is concern for its integrity, even though it is encased in concrete. The growth

K. Outlet Works Outfall.

(4) Provide closure facilities for the outlet works pipes upstream of the concrete core wall for periodic inspection and for use in the event the pipe should leak severely, thereby endangering the embankment.

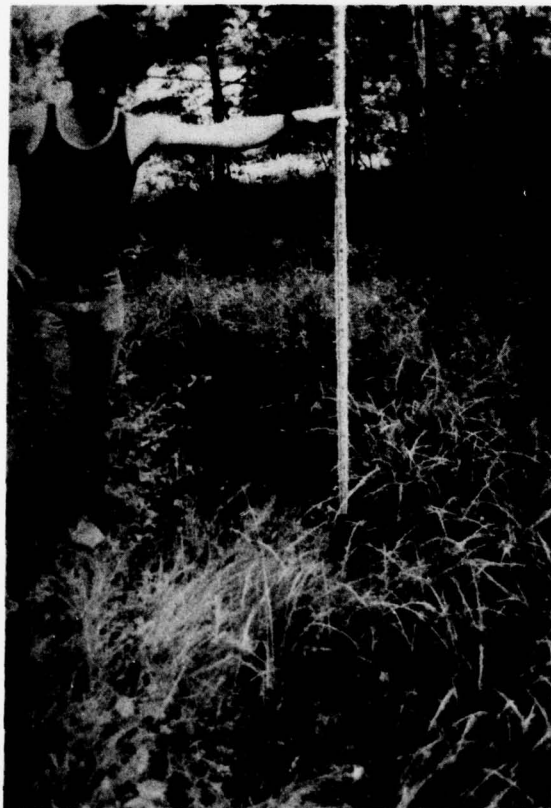
Five seepage areas and a dry flow path were observed during the inspection. These areas are shown on Plate 2. A dry flow path extends from the right end of the embankment to seepage area No. 1, which is about 40 feet right of the valve house and about 10 feet downstream of the toe of the embankment. This seepage area extends for about 75 feet along the toe. Clear localized seepage was observed in this area, which has water covering part of it. The area was heavily overgrown. The seepage was estimated at 2 gpm. The area drains into Wolf Creek by the outlet works outfall. Two additional localized and adjacent seepage area (Nos. 2 and 3) were observed 15 feet right of the outlet works pipes near the outfall. The total seepage was estimated at 10 gpm.

L. Wet Area to Left of
Valve House.

(7) Install ten or more observation wells, or other instrumentation, downstream of the axis of the dam. Two wells, or other instrumentation, should be located in the vicinity of the wet area right of the valve house. Two others should be located near the wet area left of the valve house. Another two should be in the embankment near the cracks in the core wall. The other four should be at appropriate locations to determine the general water level in downstream embankment. Data collected from observation wells or other instrumentation should be utilized in evaluating the stability of the embankment and assessing piping potential in the future. The data should also be utilized in evaluating the effects of the cracks in the core wall and in determining if other core wall cracks exist. Continue to observe the wet areas and seepage downstream from dam. If a high phreatic line is present in portions of the downstream embankment, or there is a marked increase in seepage quantity or turbidity is noted in the seepage, appropriate action should be taken to repair the core wall or to control the seepage and turbidity with properly designed drains. Action taken should be coordinated with stability studies recommended in next paragraph.
